Stone Stiles in Gloucestershire. Historical Notes and Types of Stiles

The Gloucestershire Stone Stile Project

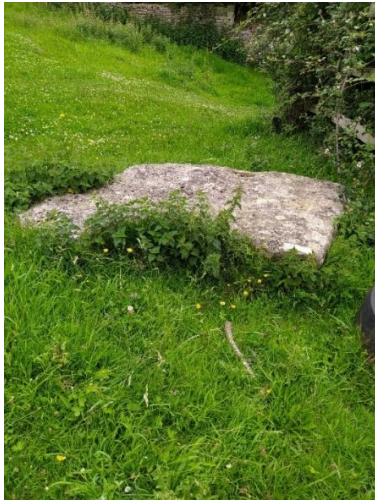
A tossed aside Slab stile, Rodborough
Photograph courtesy of Maureen Arthur

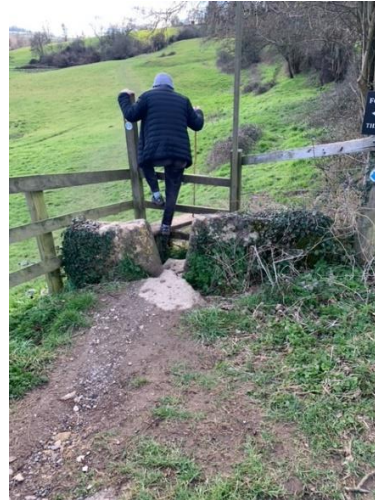
A slit stile near Sheepscombe
Photograph courtesy of Judi Bill

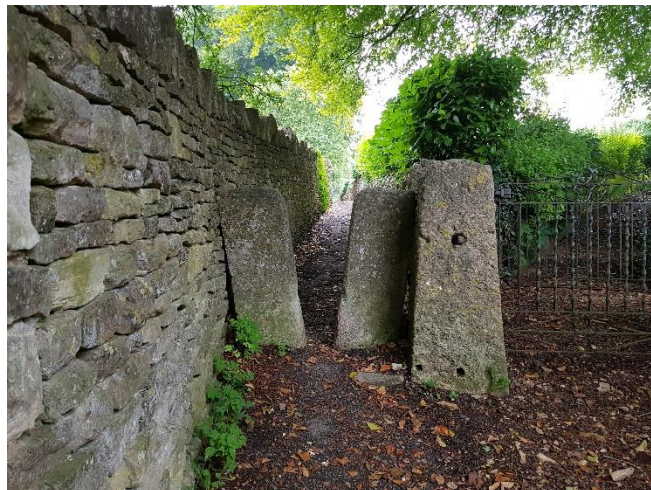
Conventional Squeeze stile in Box. Photograph courtesy of S Cernoch

This type of stile is not always effective in restraining lambs and young calves but then they tend to stay close to their mothers. Usually there are just two basic stones to a squeeze stile, as shown above. However, as shown below at Randwick Church, they could be shaped rather than sloped. A more costly construction. At Whiteshill there is a rare example of a shaped, twin squeeze stile. Double stiles called 'Coffin stiles' are found in Cornwall. Could it be that this double stile is on a coffin route and designed so that the pall bearers could pass through side by side? No one knows for sure but we do know, as stated, that in Cornwall there are coffin stiles, although not similar in construction. In Elkstone (Glos.) there is a coffin pathway.

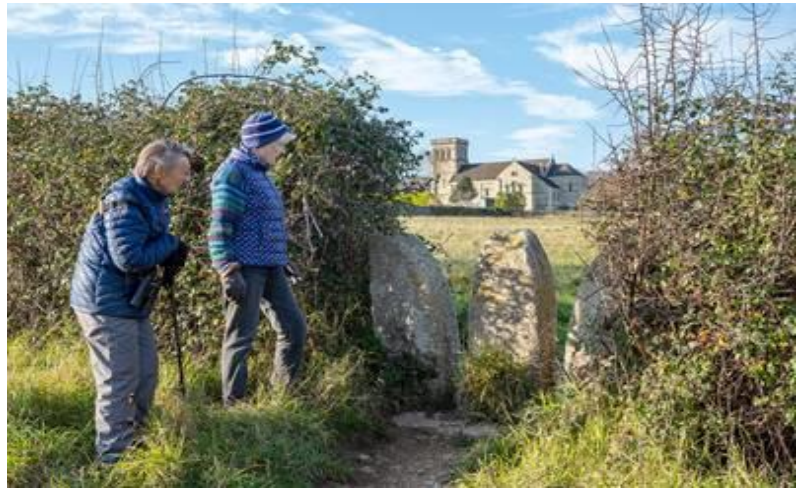
Whiteshill. Ann Dickinson, formerly of Slad, and Sue Gage, previously of Minchinhampton, pause to wonder about the stile

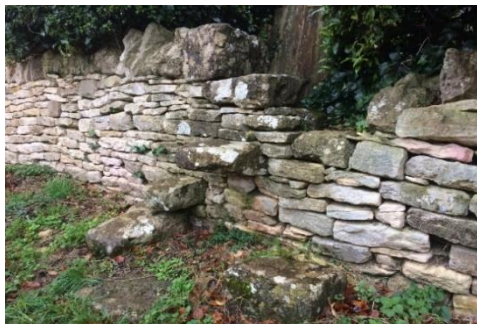
a decaying traditional step stile

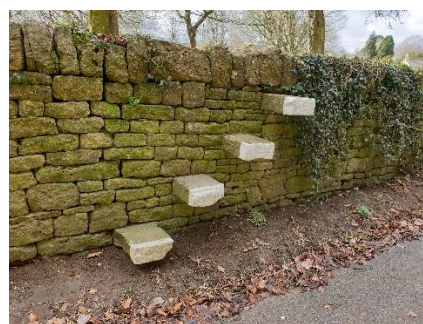
a well-maintained horizontal step stile

However, stair-like step stiles can be climbed by nimble sheep so the alternative is a stile made with stones inserted across the width of the wall and protruding out horizontally at both sides. If the step stones were too close together nimble sheep could still climb them. The ideal are thin stones with a slight slope inward. In the illustration, the extreme right above this is not so, but far enough apart to deter sheep. In this example the white paint is to warn traffic of the protruding steps

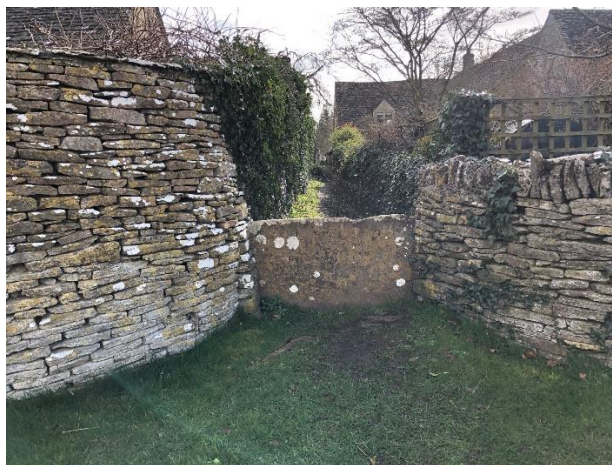
A formidable obstacle to cattle from the Common

A solid structure across the opening high enough to prevent animals jumping over and thin enough to allow people to scramble over. Slabs are more effective at retaining farm animals than Squeeze or Step Stiles but for people carrying loads they had their drawbacks in the past and today. Sometimes a metre high, the slabs do not appeal to leisure walkers who have to scramble over them.

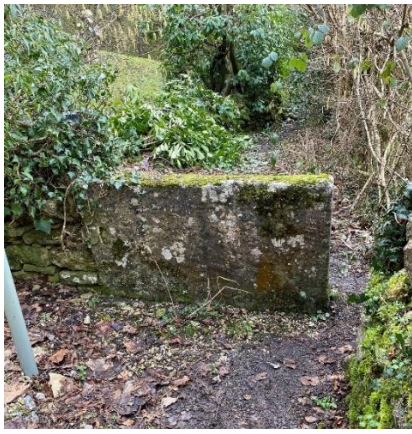
Bypassed

The slabs over time have had further problems for users. Firstly, cattle have been bred to be bigger and often top rails have to be added to the stile to keep them in. Secondly, if on a hill slope, then soil would wash down on the uphill side reducing the effective height and again giving rise to the need for a top rail. Meantime on the downhill side soil washed away adding to height. In both cases maybe sometimes a larger, much deeper slab was installed and step stones added. The top rails originally were wood but more recently round galvanised bar has been used. To meet current needs both for people and animals Slabs have been by-passed, lost in a hedgerow and modified or replaced by a wooden or metal stiles.

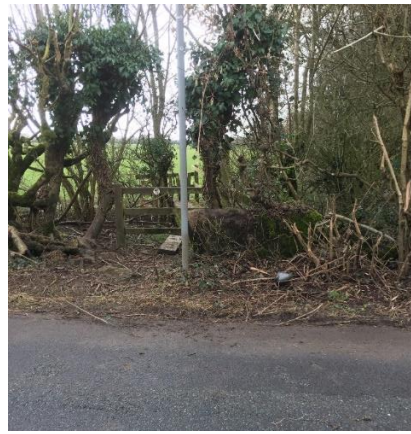
Lost- 'as I looked back I saw it'

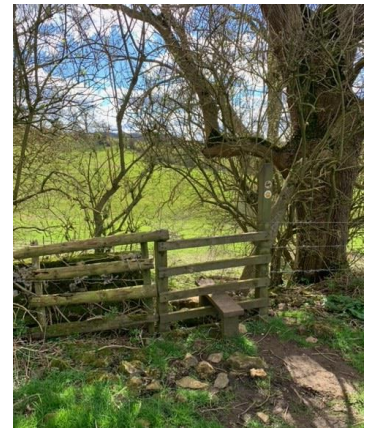
New wooden stile but old stone Slab preserved

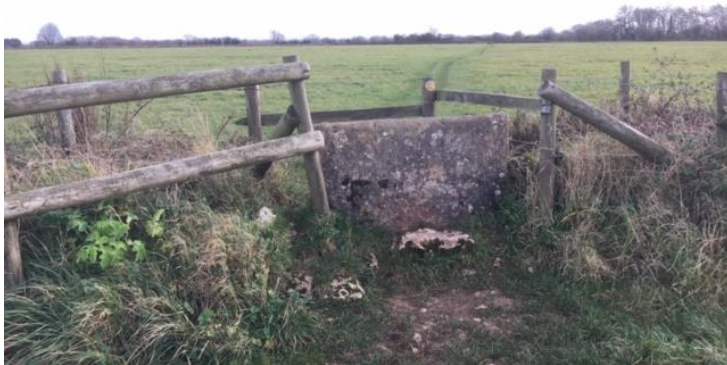
Safeguarded

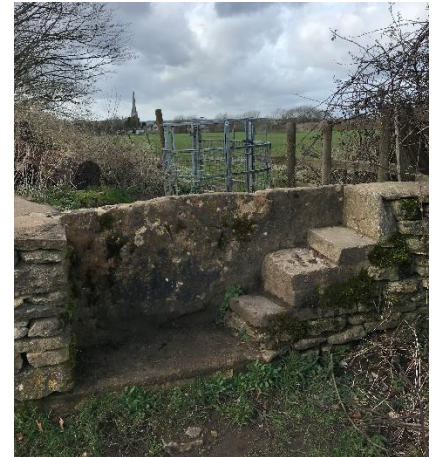
Modified and maintained

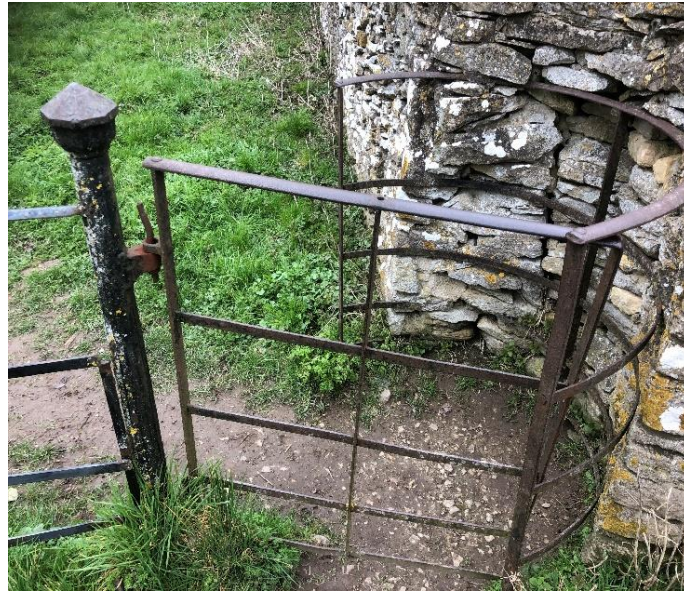
repair, replacing with a traditional wooden stile was both a quicker and cheaper option. Secondly at the same time metal stiles became available and were even easier to install and lasted longer than wood. For example, A. & J. Main & Co. Ltd. of Glasgow, who had a patent for continuous bar, had a catalogue of alternative stiles. Examples of metal stiles are being found in Gloucestershire, especially around Stroud where there was iron working.
